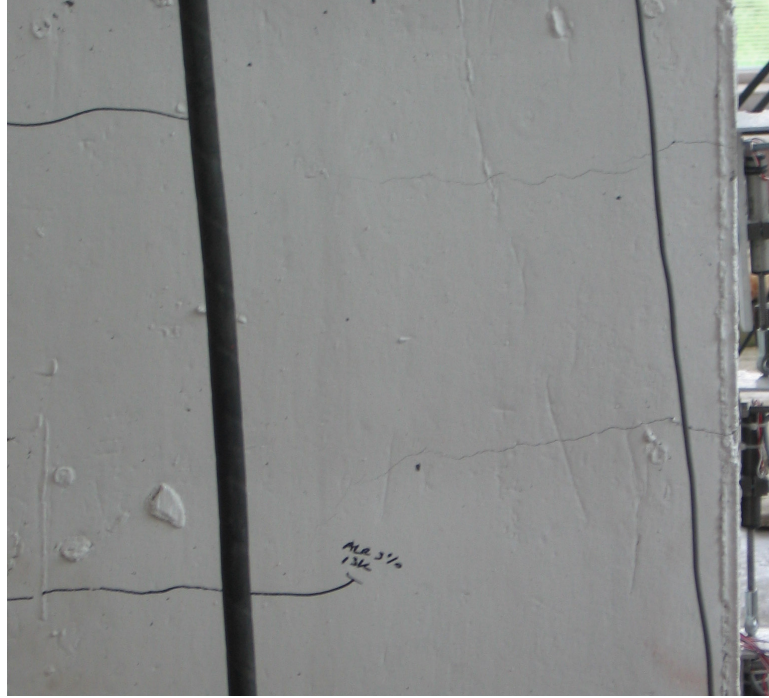
Figure 65. Flexural cracks produced in the square pile
